OVERVIEW AND HISTORIC CONTEXT FOR HISTORIC RESOURCES DISTRIBUTED ALONG THE SAN PEDRO CREEK IMPROVEMENTS PROJECT CORRIDOR, SAN ANTONIO, BEXAR COUNTY, TEXAS

FINAL

RABA KISTNER ENVIRONMENTAL, INC.

ASF12-129-03

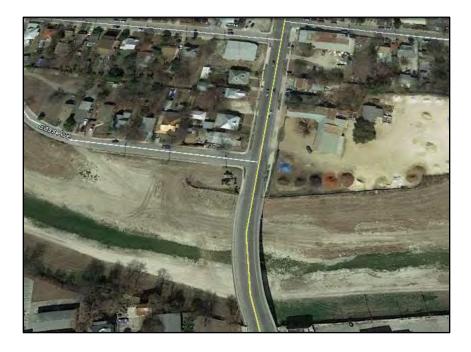
Figure 3-8. Low water crossing of San Pedro Creek near S. Flores Street.

the Corpus Christi and Laredo Road, more recently known as the South Flores Road. As at the Nogalitos crossing, even today, a low-water crossing is also actively utilized in this area (**Figure 3-8**).

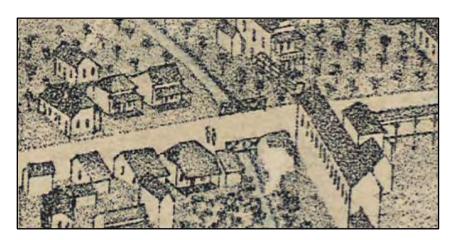
Figure 3-14. Wooden bridge with possible railing at Nueva Street, 1886.

Other bridges, such as the one at Nueva, appear to have a support infrastructure similar to later metal bridges (see figure of bridge at Nueva Str.; **Figure 3-14**). The construction of the first bridge crossing at Nueva Street may date back to the mid-1800s just before the City Council requested that the land west of San Pedro Creek be surveyed and divided into blocks and lots for sale to the residents of the town. However, even prior to this date, some residents had purchased land on the west bank of the creek as indicated by the records of sale of land.

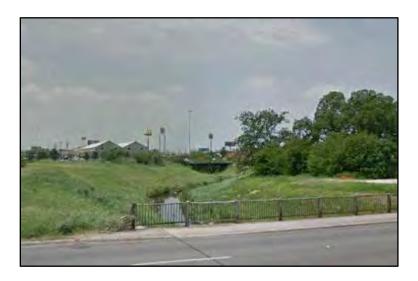
Figure 4-1. South Alamo Street Bridge and view to the South.

It is also evident from both the historical records as well as the present condition of the channel of San Pedro Creek that in addition to channel orientation, the morphology of the channel was also reconfigured. The changes involved both the construction of retaining walls along a large portion of the upper reach of the creek, as well as to make the channel of uniform width and depth. The present conditions noted along the upper reach of San Pedro Creek, specifically from the outlet tunnel near Santa Rosa Street to the creek's confluence with Alazán Creek, indicate that attempts to modify the morphology of the creek extended only to South Alamo Street. From S. Alamo southward to the confluence, the channel appears to have been widened but not walled (Figure 4-1).

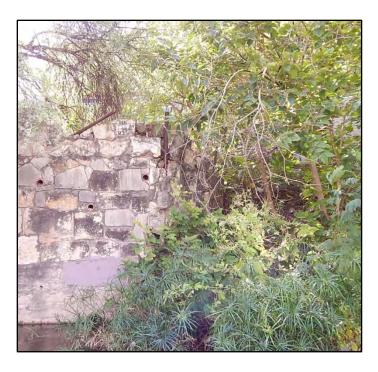
Figure 4-3. Beginning point of the west-bank retaining wall.

The western bank retaining wall begins with a short westward wall segment cut into the bank and serving as the start of the wall segment (Figure 4-3). As it turns southward and runs along the bank, the top of the wall is damaged, rocks are missing, and minimally, repair may be needed to the wall. There may be two distinct phases of construction visible on this portion of the wall. The bottom two to three courses of rock appear to be laid flat and consist of various sized rectangular limestone blocks (Figure 4-4). The very bottom course has a revetment of concrete that is peeling off in places. The concrete veer may have been added at the time of the pouring of the channel bottom assuming that it would provide added protection from erosion. The concrete creek bottom abuts the base of the wall. The remainder of the wall is constructed of various sized and oddly shaped limestone blocks that are placed at irregular angles and but well fitted together to form a massive wall that appears to be 10-12 feet in height along this segment. The rocks that make up this wall segment consist of pieces that are chiseled smooth on the exposed face, others that are rough-surfaced, and yet others that relatively flat and still preserve the chisel marks on their surfaces. Several subsurface drainage pipes are present along the wall segment. The upper two lines of pipes are situated approximately 4-6 feet below the surface while the bottom row is situated roughly 8-feet below the surface. In several places along the top of this wall segment, individual or small numbers of stones are missing and will need to be replaced. In addition, graffiti is present in localized areas on the face of the wall.

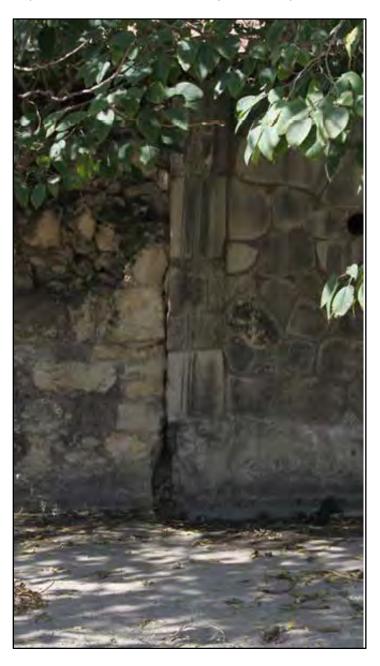
Figure 4-5. Joint between two wall segments constructed using different techniques.

This wall segment terminates in a joint at the point at which it meets a wall exhibiting a dramatically different construction technique (**Figure 4-5**). The wall terminates in well-formed rectangular limestone blocks placed on their ends to form the impression of a clear termination to the wall (**Figure 4-6**). The wall segment immediately to its left (downstream) is not joined in any manner to the one next to it.

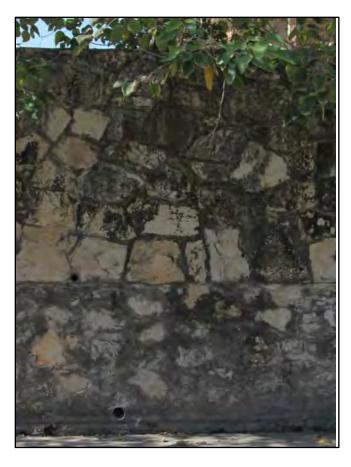
Figure 4-7. Two construction techniques seen in west wall segment.

The wall segment that follows southward from the joint is shorter than the one to its upstream side measuring only approximately 8-feet in height. It exhibits two construction techniques that may reflect two construction episodes (**Figure 4-7**). The bottoms 3-feet consists of irregularly shaped and sized limestone blocks that form a wall segment with a flat top. Buried drainage pipes are present near the very bottom of the wall and channel base. The upper 5-feet consists of larger blocks of limestone that are also irregularly positioned although the row of blocks that sit on top of the lower wall segment are flat along the wall joint. A second set of drainage pipes is found along this joint running the length of the wall segment.

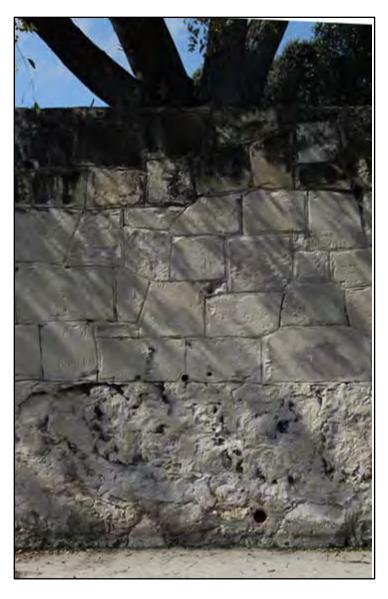
Figure 4-8. Smooth faced limestone blocks in upper west wall of San Pedro Creek.

Yet another separate construction technique is seen further south along the west wall, near the Martin Street Bridge (**Figure 4-8**). While the lower 3-feet of the wall remain consistent throughout the entire length of this segment between Martin and Santa Rosa, the limestone building blocks making up the upper segment switch from irregular sized and shaped and rough-faced pieces to smooth faced, blocks that are shaped and carefully fitted next to each other (**see Figure 4-8 vs Figure 4-7**).

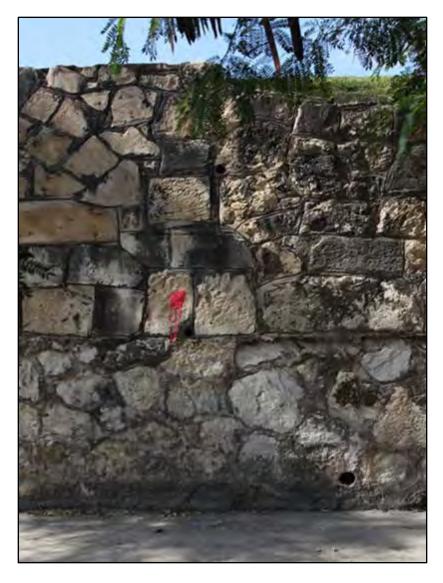
Figure 4-9. Apparent seam in upper stone wall demarcating two distinct construction techniques.

The shift in construction technique appears to coincide with the seam shown in **Figure 4-9** below.

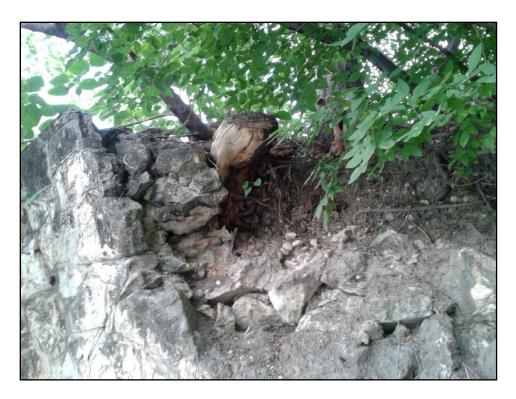
Figure 4-10. Inner- and outer-row of rocks that form the retaining wall. Note also the massive damage cause by the roots of the plants growing along the top of the bank adjacent to the wall.

The west wall segment between Santa Rosa and Martin Street is constructed of two parallel rows of rocks one on the channel-side and one on the bank-side of the creek. Any space between the two rows is filled with smaller rocks some held in place by mortar while others appear to be dry-stacked (**Figure 4-10**).

Large segments at the top of this wall are damaged due to root impacts (**Figure 4-10**), and at least in one place (**Figure 4-11**), a large hole has formed near the top of the lower portion of the wall near the seam between the two stacked walls. This hole is a product of erosion that began at the top of the bank (**Figure 4-12**) and penetrated below the bank surface and exited at a structural weak spot, the seam between the two walls.

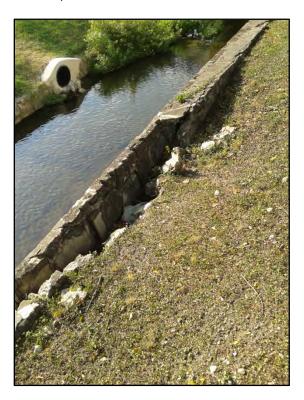
Figure 4-12. Erosion of the top of the west bank.

Damage to the tops of the wall is not only caused by roots but also the long-term effects of the installation of a retaining rails made of joined piping on top of the wall (**Figure 4-4**), and later generations of retaining walls made of concrete (**Figure 4-13**).

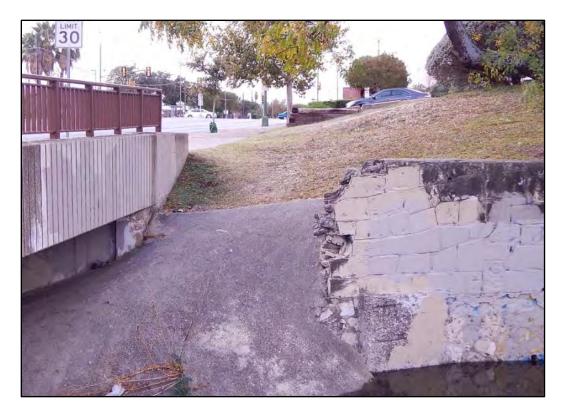
Figure 4-14. Break in stone wall created to allow for construction of Martin Street Bridge.

Finally, the portion of the wall immediately north of the Martin Street Bridge has been ;removed to allow for the construction of the bridge and the concrete apron that prevents the erosion of the bridge footing on the west bank of the creek (**Figure 4-14**). Since its construction, and lacking any support, the wall has begun to lean inward with a sizable gap developing between the bank fill and the back-side of the wall (**Figure 4-15**).

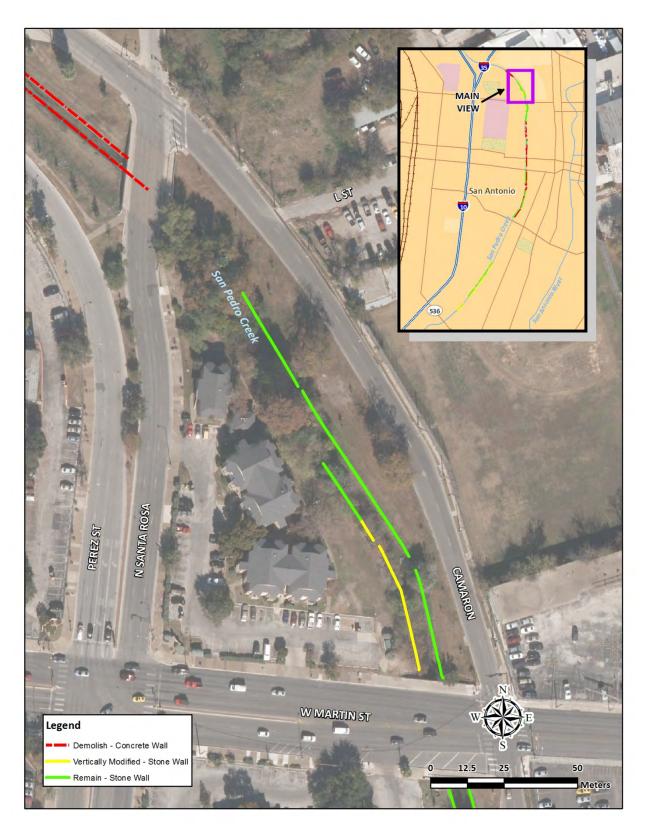
Figure 4-16. Proposed impacts to the west and east bank retaining walls between Santa Rosa and Martin Street.

Figure 4-16 illustrates the proposed impacts and modifications to the retaining walls along the west and east banks of the creek between Santa Rosa and Martin Streets. Note also that the concrete retaining walls that connect the stone retaining walls to the tunnel outlet, marked in red on the figure, will be demolished.

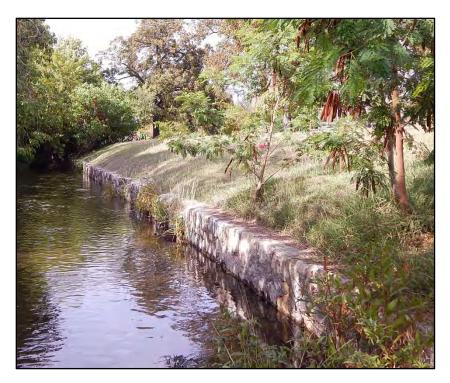
Figure 4-17. East wall of San Pedro Creek looking north from middle of block.

The east wall of the San Pedro Creek channel in this segment is much shorter than the west wall, measuring only approximately 2 to 3-feet in height. From its beginning just south of Santa Rosa Street to the Martin Street Bridge, the east wall of the creek is only two courses high (**Figure 4-17 and 4-18**).

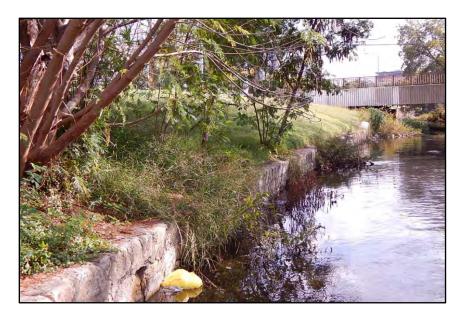
Figure 4-18. East wall of San Pedro Creek looking south from middle of block; note Martin Street Bridge in background.

The wall is in relatively good condition with only localized damage (i.e., missing rocks **Figure 4-18**), although the vegetation that has caused the damage on the west bank is growing liberally along the east bank of the channel, as well. As noted in Figure 4-16, the east bank retaining walls will remain unaltered as part of the proposed project.

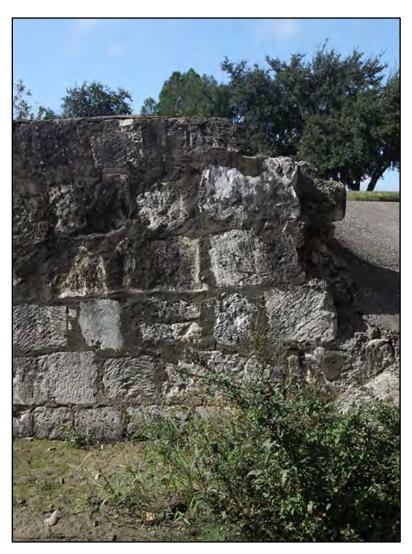
Figure 4-19. Beginning of stone wall south of Martin Street Bridge.

As immediately north of the Martin Street Bridge, the stone wall is cut through just south of the Martin Street Bridge to allow room for the installation of the concrete apron that protects the base of the bridge (**Figure 4-19**).

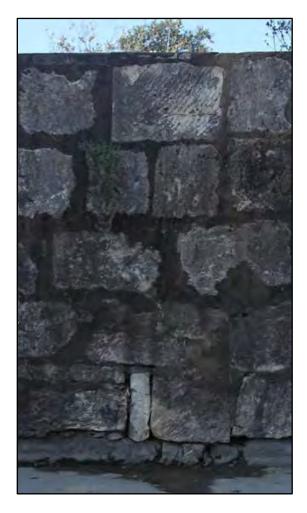
Figure 4-20. Vertical spacers in wall segment just south of Martin Street Bridge.

slabs are present in the northern portion of this segment of the stone wall but these slabs terminate at a distinct seam in the wall and are replaces with square drain holes scattered throughout the wall (**Figure 4-20 and 4-21**).

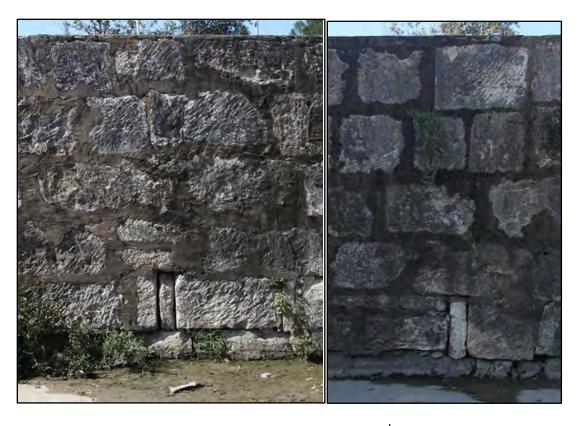
Even within a wall segment that appears to have been constructed using the same technique, however, there are differences in the rocks employed in the construction suggesting either different construction episodes, different rock quarries, or different loads from the same quarry (**Figure 4-22a and b**).

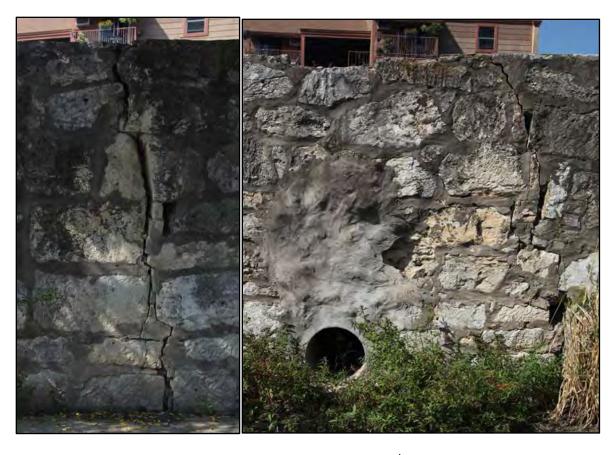
While in general, the wall segment is in better condition than the segment north of Martin Street, structural weaknesses at the joints between distinct construction episodes are failing and are endangering the integrity of the wall (Figure 4-23a). In addition, more recent impacts to the wall (see Figure 4-23b), such as the installation or reinforcement of drainage culverts also continues to impact the integrity of the walls. Finally, the bases of the walls are beginning to experience the effects of erosion as the concrete mortar has been removed from along the bottom row of rocks (see Figure 4-22b). It is unclear how this mortar erosion impacts the structural stability of the wall unless the water is also removing fill found behind the base of the wall.

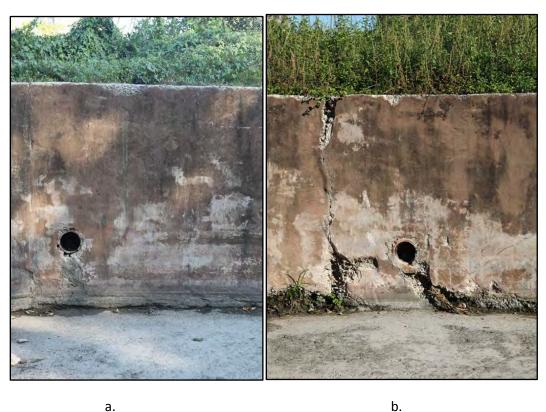
The east bank retaining wall is the first of the segments with a property ID number. It is identified as ID number 101560. The east bank is a completely different construction technique than the west bank. This portion of the creek is concrete walled (**Figure 4-27**). There are round drainage ports near the base of the wall at regular intervals. Portions of the wall have cracks and chips that seem to illustrate that the east bank is not a cut stone wall with a cement revetment.

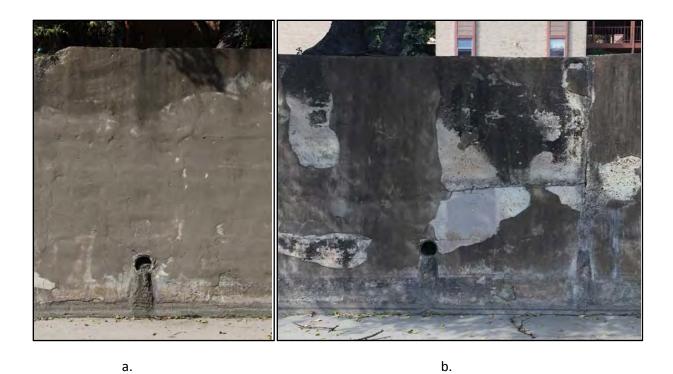
Figure 4-28. Portions of the west wall near Salinas St (a) and W. Travis St (b).

This portion of the west bank of San Pedro Creek is stone masonry with concrete revetment. Round clay pipe drain holes are at a fairly constant height and intervals along the west wall (see **Figure 4-28**).

Note that the west bank retaining wall along this segment of the creek is to remain intact for approximately $2/3^{rd}$ of its northern end. The remaining $1/3^{rd}$ in the vicinity of the Travis Street Bridge will be demolished (**Figure 4-29**).

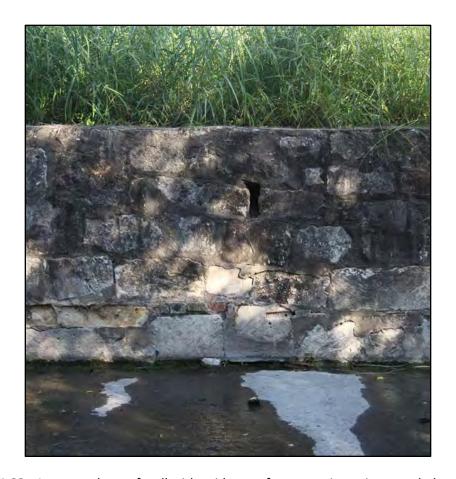
Near the center of this portion of the east wall, there is an area that appears to have been partially built with recycled materials (**Figure 4-32**). Near the base of the wall, there is an area with four bricks making up part of the wall construction. Also, there is a large limestone rock at the base with an apparent chiseled rectangular indention. The bricks and the chiseled limestone block suggest that recycled materials may have been incorporated into the wall during construction.

Figure 4-32. Area near base of wall with evidence of construction using recycled materials.

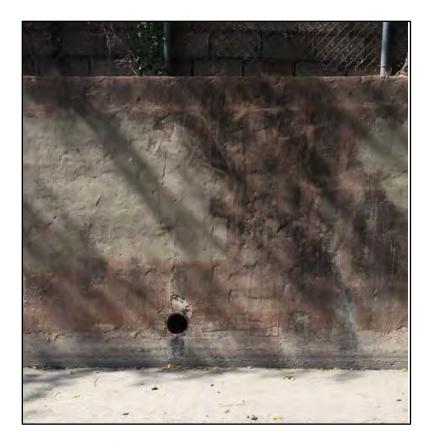
The west-bank retaining wall along this stretch of the creek is identified with property ID number: 101752. This portion of the west bank of San Pedro Creek is concrete walled, including under both bridges. There are areas of cement revetment along the wall that appear to be patches or water proofing over concrete walls. The base along the entire length of this segment is continuous concrete and the round clay pipe drain holes are at a fairly constant height and intervals along the west wall (Figure 4-34).

Figure 4-34. Typical view of the west bank between W. Travis St and W. Houston Street.

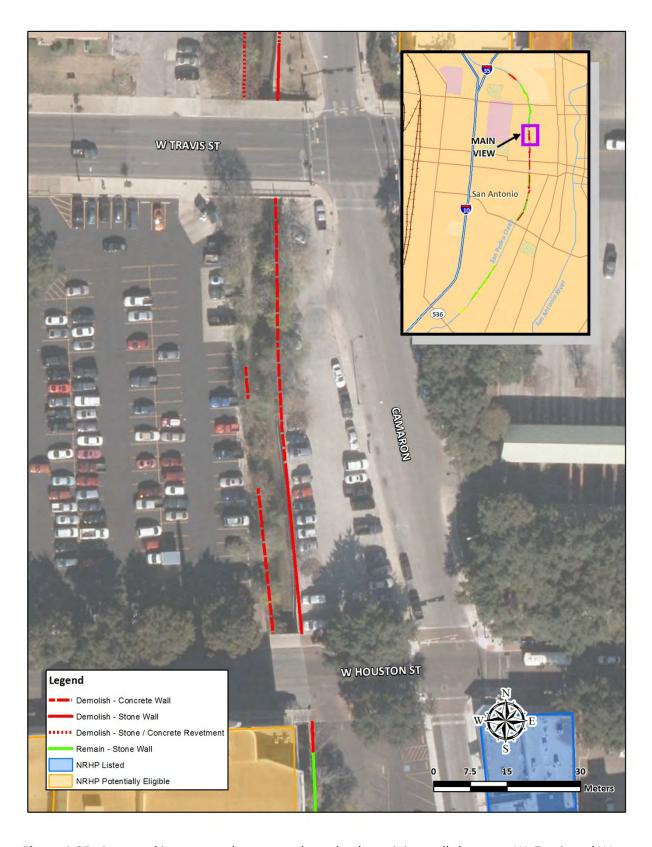
Figure 4-35. Proposed impacts to the west and east bank retaining walls between W. Travis and West Houston Street.

Figure 4-35 shows the proposed impacts to the west and east bank retaining walls that fall between W. Travis Street and West Commerce Street. Note that between Travis and W. Houston, the plans call for the demolition of the stone and concrete retaining wall along the west banks of the creek.

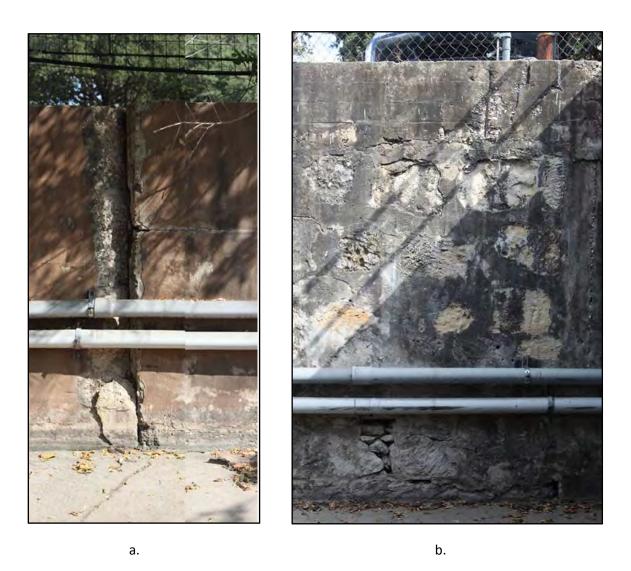
The entire length of this portion of the east bank has two utility conduit pipes anchored to the wall and they continue to the south. The northern 2/3rds of the east bank retaining wall between the two street bridges appears to be of concrete construction (**Figure 4-36a**). The 1/3rd adjacent to the Houston Street Bridge is constructed using limestone blocks and has a cement mortar revetment (**Figure 4-36b**).

Figure 4-36. Concrete and limestone retaining wall segments between Travis and Houston Streets.

The proposed plan calls for the demolition of the east bank retaining wall along its entire length between the Travis and Houston Street Bridges (**Figure 4-35**).

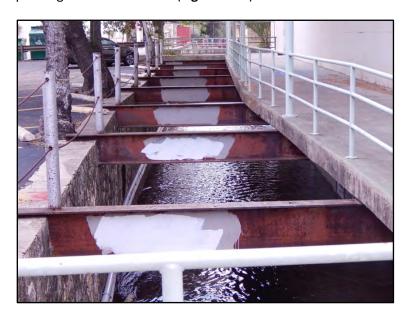
Figure 4-37. I-beams supporting sidewalk along Alameda Theater.

The west bank of the creek immediately south of the Houston Street Bridge forms the wall of the Alameda Theater. It is a solid concrete wall with graffiti present under the suspended sidewalk that is held up by I-beams spanning the creek channel (**Figure 4-37**).

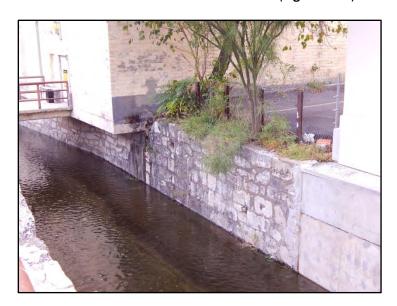
Figure 4-38. Stone wall segment fronting an alley between existing buildings.

The stone wall picks up immediately south of the theater (**Figure 4-38**) in an area that forms an alley between two neighboring buildings. A footbridge appears to have spanned this portion of the channel judging from its sawed concrete remnant noted on the east bank (**Figure 4-39**).

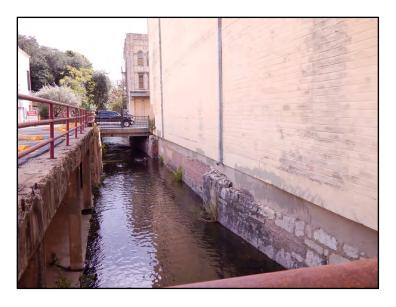
The stone wall continues along the west bank forming the wall of the Dollar General Store (**Figure 4-40**). Here, the stones are conjoined with bricks and eventually, only bricks form the west retaining wall of the creek (**Figure 4-41**).

Figure 4-40. Stone and brick wall along the Dollar General Store.

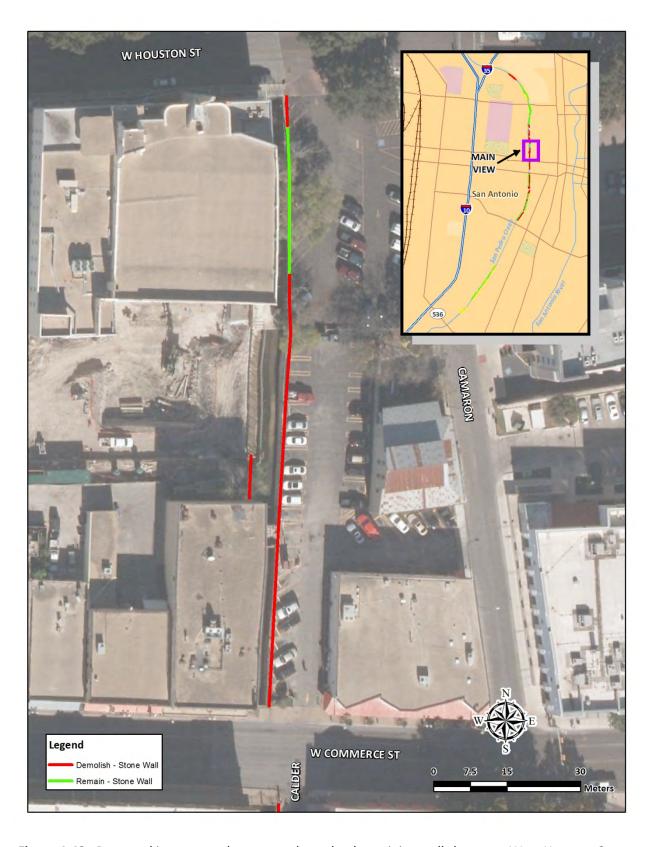
Figure 4-42. Proposed impacts to the west and east bank retaining walls between West Houston Street and West Commerce Street.

The proposed plans call for the demolition of the short segment of stone wall remaining in the west retaining wall of the creek immediately south of the Alameda Theater (**Figure 4-42**).

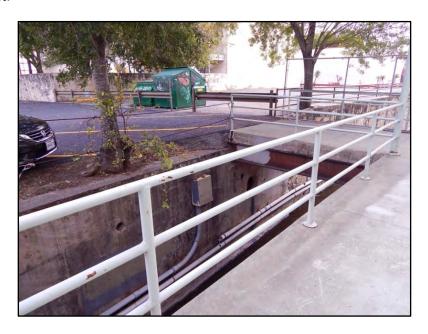
Figure 4-45. Cement revetment covering stone wall between Houston and Commerce Street.

A short segment of the stone wall is covered by a cement mortar revetment in the vicinity of a footbridge spanning the creek (**Figure 4-45**). South of this footbridge the stone wall re-emerges and continues for a short distance before it is replaced by a poured concrete wall (**Figure 4-46**) which is eventually replaced by a brick wall across from the Dollar General Store as the wall approaches Commerce Street.

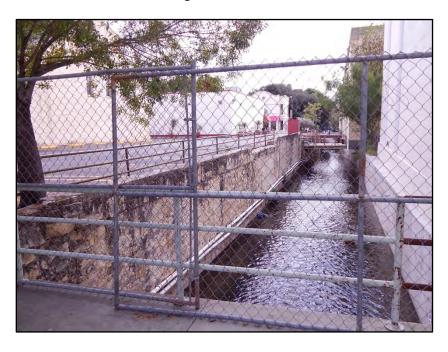
Figure 4-46. Stone wall and concrete wall meet along east bank of creek, across from alley between Alameda Theater and the Dollar General Store. Former footbridge was at the seam of the concrete and rock walls.

Two foot bridges span the creek between the Houston Street and Commerce Street. These foot bridges are potentially eligible for listing to the NRHP (**Figure 4-46**; see also **Figure 4-39**).

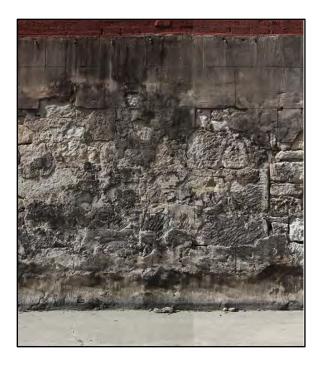
Clear evidence of a concrete revetment is present along the west wall in the immediate vicinity of Dolorosa Street. Here, the cement revetment is peeling and therefore exposing the underlying stone wall (**Figure 4-48**). Also note the fact that the cement revetment contained the etched outlines of stone blocks giving a faux stone block appearance.

Figure 4-48. Peeling concrete mortar revetment exposing underlying stone wall.

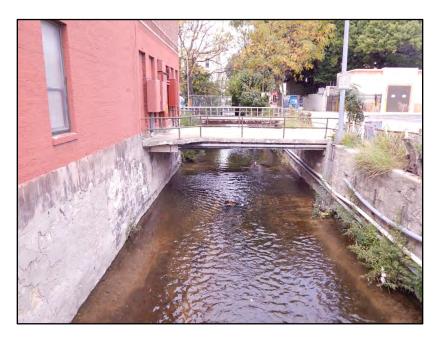
Two I-beam supported concrete bridges are present (**Figure 4-49**) within this stretch of the creek. One connects Calder Street with a parking lot on the west bank of the creek while the other serves as supply access to the adjoining business establishment (**Figure 4-49**). Yet a third bridge was formerly present but has been demolished (**Figure 4-50**). It had been located immediately behind the Spanish Governor's Palace complex.

Figure 4-49. Remaining bridges behind the Spanish Governor's Palace.

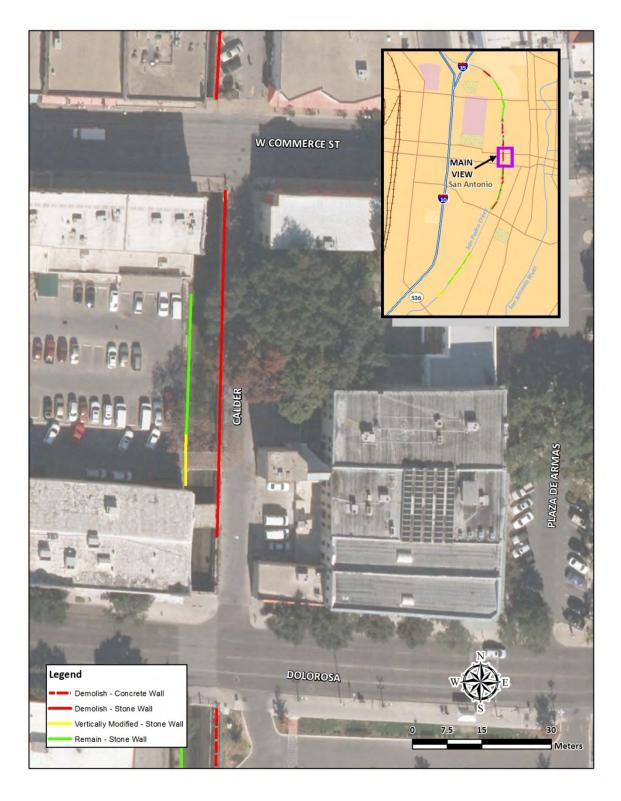
Figure 4-51. Proposed impacts to the west and east bank retaining walls between West Commerce Street and Dolorosa Street.

Figure 4-51 shows the proposed impacts to the west and east bank retaining walls that fall between W. Commerce Street and West Dolorosa Street. The plans call for the retention of the stone wall in the center of the block and the vertical modification (increasing height) of a short segment that is under one of the bridges still existing behind the Spanish Governor's Palace and leading to the parking lot on the west bank of the creek.

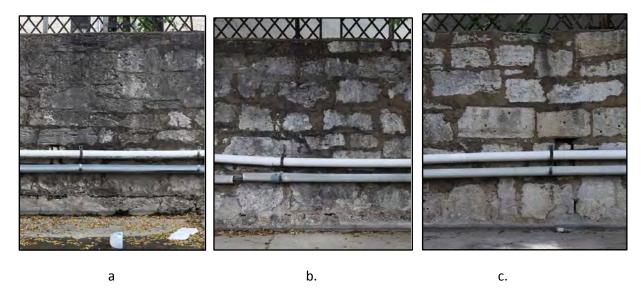
Figure 4-52. Distinct wall construction styles along east retaining wall.

The entire east retaining wall of the creek between the aforementioned two bridges is constructed of limestone blocks. The wall is approximately eight feet high and in parts two and in others three different conduits are attached and run along the base of the wall. The attachments result in localized impacts to the wall but otherwise minimal damage is noted to the entire segment (**Figure 4-52**).

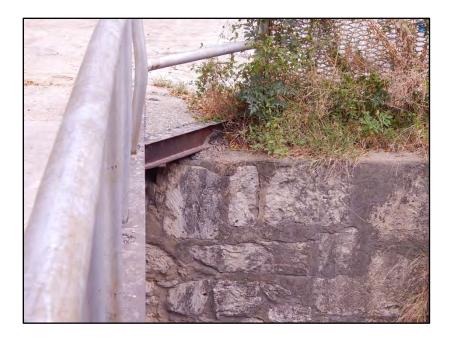
The bridges that span this segment of the creek are built on top of rather than imbedded within the stone retaining wall (Figure 4-53).

Figure 4-53. Bridge construction spanning San Pedro Creek near Dolorosa Street.

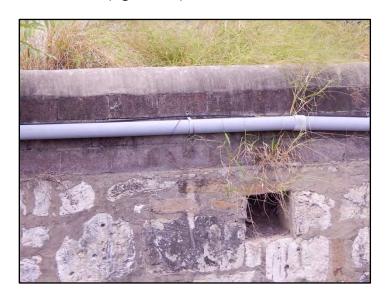
The entire west bank retaining wall is constructed of limestone blocks along this stretch of the creek. Near the Dolorosa Street Bridge, the stone wall retains a concrete cap but this does not appear to have impacted the integrity of the underlying wall (**Figure 4-54**). This cap is present only within the limits of the property which it is bound within (**Figure 4-55**).

Figure 4-54. Concrete cap on top of stone west retaining wall.

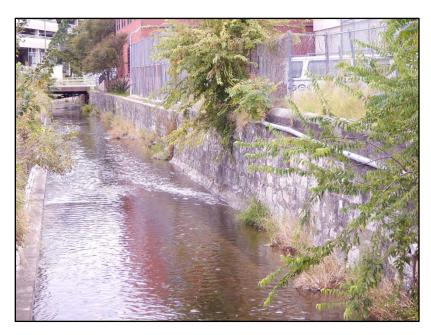
Figure 4-55. Stone retaining wall along west bank of creek, note concrete cap along right edge.

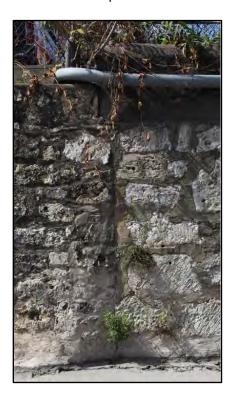
As in other previous instances, a number of multiple construction styles are apparent along this segment of the retaining wall (**Figure 4-56**). In addition, at least one clear seam is evident along the wall (**Figure 4-57**) indicating yet again that the construction of the retaining wall was phased so that segments would be laid as funds, stone and labor were available.

Figure 4-57. Seam between two distinct construction phases or styles along retaining wall.

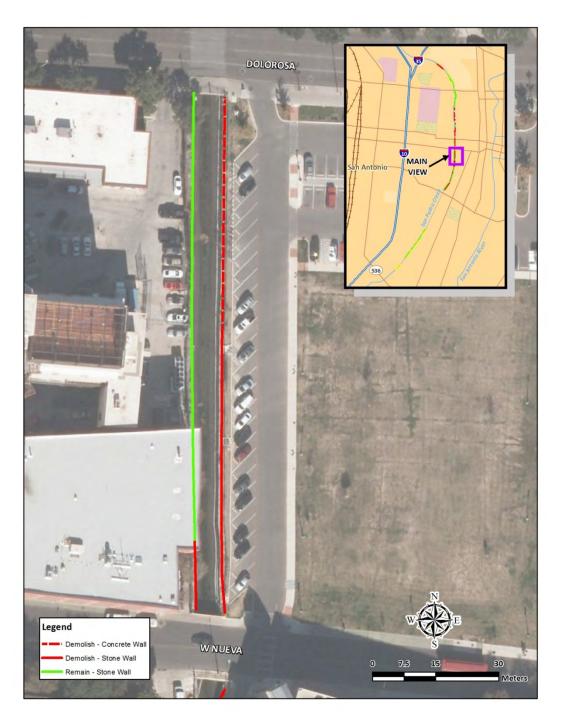
Figure 4-58. Proposed impacts to the west and east bank retaining walls between West Dolorosa Street and West Nueva Street.

The proposed plans call for not impacting much of the western stone retaining wall between Dolorosa and W. Nueva. The exception is a short segment of the wall in front of the Bexar County Annex. This wall segment is slated for demolition (**Figure 4-58**).

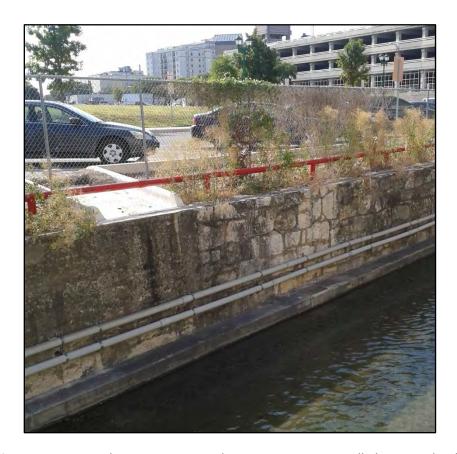
The retaining wall along the east bank of the creek is constructed of poured concrete along the northern half of this stretch. The remaining portion, beginning roughly about 2/3rds of the way along the block, consists of limestone blocks (**Figure 4-59**). A narrow concrete conduit-bank runs along the base of the wall and two conduits are attached to the wall (**Figure 4-60**).

Figure 4-59. Seam between stone and concrete retaining wall along east bank.

The proposed plans call to the demolition of the entire stretch of retaining wall along the east bank of the creek between Dolorosa and Nueva Streets (**Figure 4-58**).

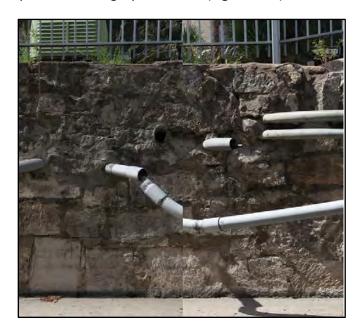
A single conduit is attached to the wall and runs along much of its length. Several conduits penetrate the wall immediately south of the Nueva Street Bridge (**Figure 4-62**). In addition, recent drain installations have also impacted the integrity of the wall (**Figure 4-63**).

Figure 4-62. Conduits that impact the stone wall immediately south of Nueva Street Bridge.

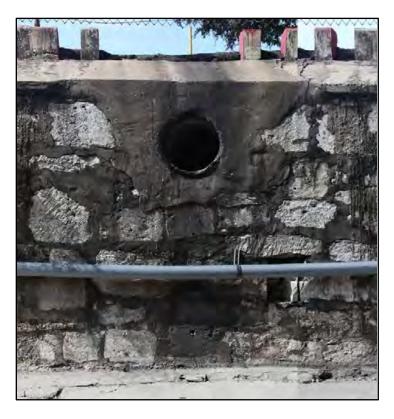
Figure 4-63. Impact to stone wall by drain pipe installation.

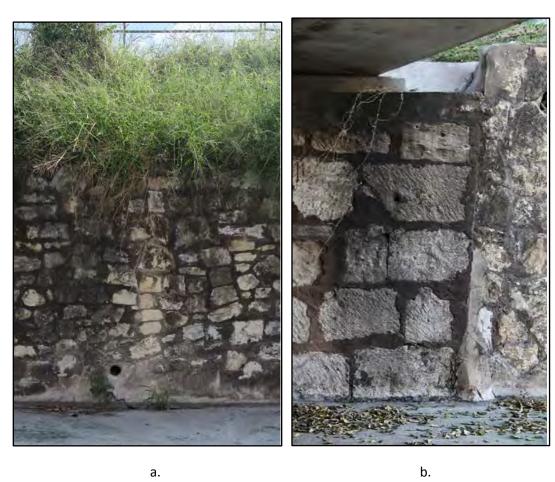
The entire segment of the east bank retaining wall is constructed of limestone blocks. The wall is approximately seven feet tall and much of it is constructed of uncut, irregularly sized and shaped limestone (**Figure 4-68a**). The stone work changes to large rectangular cut limestone blocks under the Cesar Chavez Blvd Bridge. The bridge itself is built on top of rather than imbedded into the stone retaining wall (**Figure 4-68b**). The stone work appears to be relatively consistent along this segment of the retaining wall suggesting perhaps that it was built at the same time.

Figure 4-68. Typical stone work in much of this wall segment, note large cut blocks under bridge.

The proposed plans call the demolition of the east retaining wall along the entire stretch from Graham Street to C. Chavez Blvd (Figure 4-67).
